Manhole Inspection Summary

Manhole # S06CC2014MH

Location Address: **6902 PARK HEIGHTS AVE**

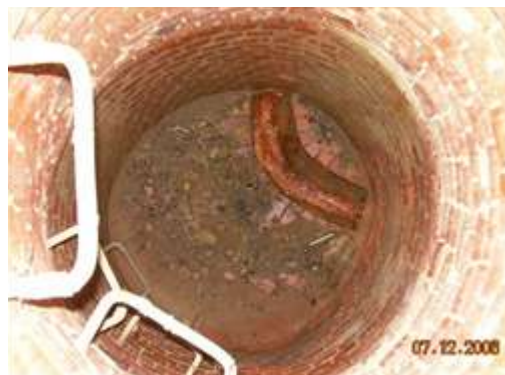
Top View

Infiltration: ☐ None ☒ **Joint** ☐ Cracks ☒ **Mortar** ☐ Roots ☐ Wall

Infiltration: ☐ None ☐ Joint ☐ Cracks ☒ **Mortar** ☐ Roots ☒ **Wall**

Surcharge ☒ **Evidence Of Surcharge** Depth: **1** (ft.) ☐ Active Surcharge Present

Adjustment and Corbel infiltration.
Evidence of surcharge - Bench debris.

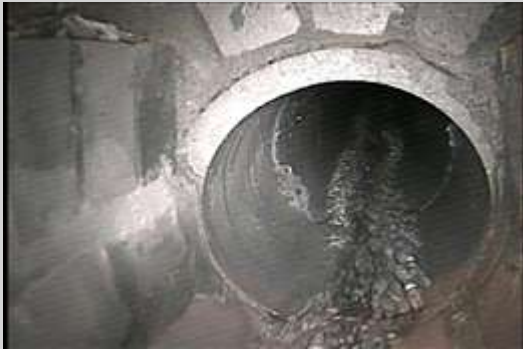
8 in. Circular Gravity Sewer Pipe Out @ 12 O'Clock

Infiltration: **Evidence** Pipe Seal Cond: **Unknown**

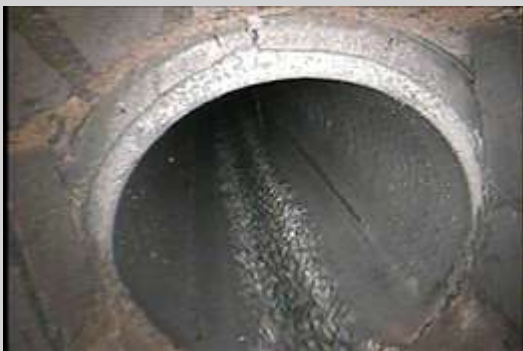
8 in. Circular Gravity Sewer Pipe In @ 3 O'Clock

Infiltration: **None** Pipe Seal Cond: **Cracked**
